# REGIONAL WATER QUALITY NEWSLETTER

DATE: Report for February 2014

ASU Regional Water Quality Partnership

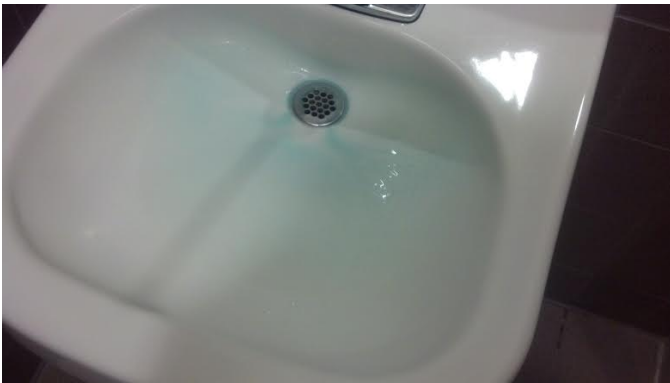
ASU has many new buildings (lucky us), but we have discovered high levels of copper in the tap water of these new buildings. Our own research building had copper levels above 1.3 mg/L on a recent sampling. Many of the water fountains and fixtures have classical “blue” stains associated with copper.

The City of Tempe water outside the building contains  $< 0.1$  mg/L and it is clear the copper is coming from corrosion of the pipes in building.

Industrious students have sampled other buildings on campus, and found a general relationship between the age of the building and copper levels – with buildings brought on-line within the last 2-4 years all having copper levels above 0.3 mg/L.

As copper pipes age, they build up impermeable scales on the inside of the pipes. Until these scales develop, lighter and fluffier scales of blue copper deposits such as malachite develop. When flushed by moving water, these fluffier scale slough off and come out the tap – giving blue water. Does anyone know how long it takes for new copper pipes to age, and develop scales that yield low copper levels?
